## Urgent Field Safety Notice

July 2022

**Subject: Field Safety Notice** – Continued use of older Model 2868 software on Model 3120 ZOOM™ programmers to support transvenous CRT-Ds and ICDs until supply chain constraints on newer programmers<sup>1</sup> are resolved. See Appendix A for affected GTINs (Boston Scientific Field Action Reference: 92822246-FA)

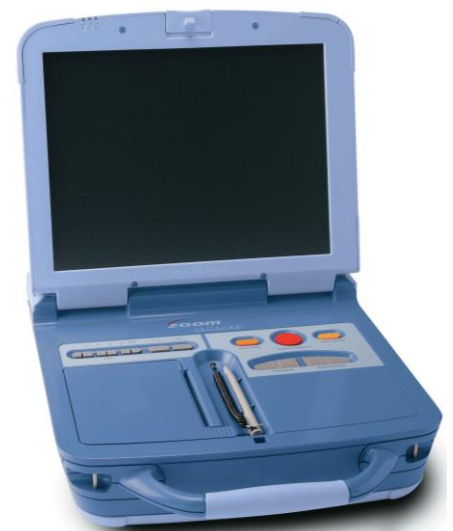
**Figure 1.** Model 3120 ZOOM Programmer

- Global supply chain challenges have constrained availability of the newer programmers.
- Until the supply chain constraints are resolved locally, you may continue using older 3120 ZOOM programmers.
- The 2868 software on the 3120 ZOOM programmer has been uninstalled or is outdated. As such, users may observe unexpected behaviors when attempting communications with transvenous defibrillators<sup>2</sup> including the potential inability to interrogate or the display of incorrect/missing parameters<sup>3</sup>
- A software update has been developed to resolve some of the disruptive behaviors associated with continued use of 2868 software on the 3120 ZOOM programmer. Boston Scientific will release software after local approval.

- The risk of insufficient programmer supply outweighs the risks associated with these unexpected behaviors, therefore, Boston Scientific recommends continued use of 3120 ZOOM programmers for transvenous defibrillators until sufficient supply of the newer programmers can be achieved locally.

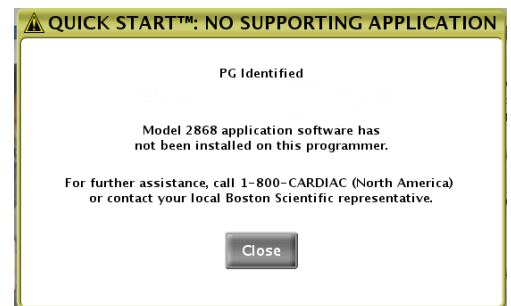
As part of this software upgrade, product labeling was updated to direct users to avoid using outdated 2868 software and Boston Scientific began uninstalling this software from 3120 ZOOM programmers. Soon after, Boston Scientific became aware of the likelihood of pandemic-induced global supply chain constraints on 3300 LATITUDE programmer supply and discontinued the uninstallation process in most regions because there could be insufficient programmers to support implanted TV defibrillators. When 2868 software is uninstalled, the 3120 ZOOM programmer can no longer interrogate TV defibrillators. If a user attempts to interrogate a device without applicable software, a message is displayed (Figure 2) to notify the user that software has been uninstalled on the programmer. To determine if a programmer has 2868 software, select “About” on the programmer screen and review the list of software applications installed. Please note that, 2868 software is the only outdated application on the 3120 ZOOM programmer.

**Figure 2.** Message that displays when a Boston Scientific TV defibrillator is interrogated by a 3120 ZOOM programmer if 2868 software is uninstalled.

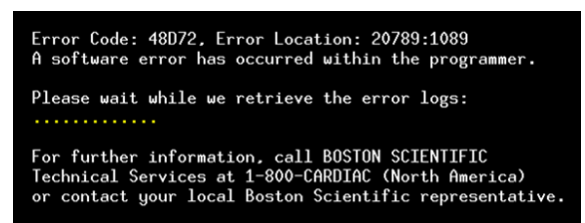
If a TV defibrillator has a stored SAM episode, the 3120 ZOOM programmer will present the Error Log and Halt message in Figure 3, and the user will need to use a 3300 LATITUDE programmer to interrogate the defibrillator. This error message (Figure 3) is an indication of an incompatibility of any 3120 ZOOM programmer with that specific TV defibrillator. However, the TV defibrillator will operate as intended with the permanently programmed settings. After power cycling the programmer, it may be used to interrogate TV defibrillators without stored SAM episodes. If the user attempts to interrogate the same TV defibrillator with the 3120 ZOOM programmer, the Error Log and Halt message will display again.

**Figure 3.** The specific Error Log and Halt Message on 3120 ZOOM Programmer when interrogation of TV defibrillator with a SAM episode is attempted.

The behavior most likely to be attributed to potential harm when using a 3120 ZOOM programmer is the inability to interrogate a TV defibrillator (e.g. Figure 2 or 3). There have been 9 reports of this behavior which have resulted in a delayed/prolonged procedure until the defibrillator can be interrogated with a 3300 LATITUDE programmer. Furthermore, there has been a single report of delays in reprogramming for phrenic nerve stimulation and a single report of an inability to interrogate for delivery of commanded therapy. None of the reports associated with 3120 ZOOM programmer have resulted in permanent injury.

- 1) If unable to interrogate a TV defibrillator with a 3120 ZOOM programmer, use a 3300 LATITUDE programmer instead. If this behavior occurs, STAT PACE, STAT SHOCK, and DIVERT THERAPY programmer operations<sup>4</sup> are not available through a 3120 ZOOM programmer, so external pacing/defibrillation or magnet application (to divert shock) may be required if a 3300 LATITUDE programmer is not immediately available.

A 3120 ZOOM programmer update to 2868 software has been developed to resolve the Error Log and Halt behavior associated with TV defibrillators having a stored SAM episode. This software update does not represent a material reduction in patient safety risk, however, it does prevent clinical workflow interruptions and will be released subsequent to approval.
