**Urgent Field Safety Notice - Cover letter for  
EMBLEM™ Subcutaneous Implantable Cardioverter Defibrillators (S-ICDs)  
(Models A209 and A219)  
EMBLEM™ S-ICD Subcutaneous Electrode (Model 3501)**

**Subject: Important Medical Device Advisory Update to August 2019 Advisory**

**Subject: Important Medical Device Advisory** Update to August 2019 Advisory – A total subset of approximately 38,350 active EMBLEM™ Subcutaneous Implantable Cardioverter Defibrillators (S-ICDs) (Models A209 and A219) with an elevated likelihood for early replacement (Boston Scientific Field Action Reference: 92400926D-FA)

**Subject: Important Medical Device Advisory** - EMBLEM™ S-ICD Subcutaneous Electrode (Model 3501) with a potential for electrode body fracture (Boston Scientific Field Action Reference: 92384167-FA).

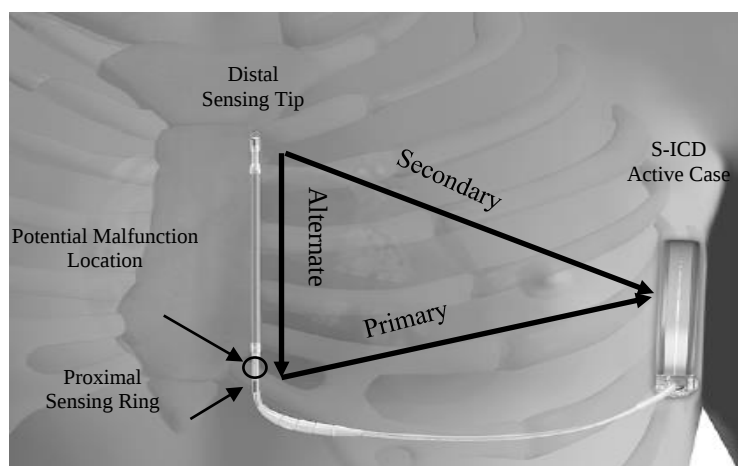
During assembly of the EMBLEM S-ICD Subcutaneous Electrode, a small amount of adhesive is applied to a location just distal to the proximal sense ring. Over time, mechanical stresses on the electrode body at this location may create the potential for a fatigue crack to initiate from the outer lumen. This crack then propagates inward toward the center-oriented distal sense conductor, eventually resulting in a fracture of the two high voltage conductors. To date, Boston Scientific has received 27 reports of electrode body fractures at this location; refer to Figure 1 for an image of the S-ICD system *in vivo*, note the potential fracture location with respect to the programmable sensing configurations (i.e., Primary, Secondary or Alternate).

**Figure 1. S-ICD System *in vivo* depicting programmable sensing configurations and the potential malfunction location.**

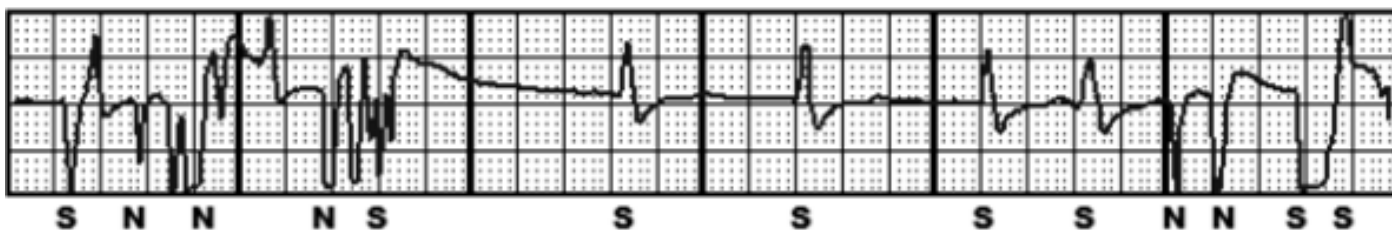
Manifestation of this fracture can be detected in two ways: non-physiologic mechanical artifacts and/or the presence of a high impedance alert condition. The method of detection, as well as timing of detection, are dependent on programmed sensing configuration and progression of conductor fractures. A distal sense conductor fracture may be detected via non-physiologic, mechanical artifact precursors (see Figure 2) stored in episode electrograms (S-ECGs) within systems programmed to Secondary or Alternate sensing configurations. These precursor artifact signals may also result in an inappropriate shock. S-ICD systems programmed to an Alternate or Secondary sense configuration have exhibited precursor artifact signals as early as two months before the fatigue crack propagates to the high voltage conductors. If both high voltage conductors fracture, shock therapy will be unavailable.

**Figure 2. Example of non-physiologic, mechanical artifact; precursor artifact signals span one or both amplitude limits of the S-ECG.**
