| Welch Allyn, Inc.<br>4341 State Street Road<br>Skaneateles Falls,<br>NY 13153 USA | <b>URGENT: Field Safety Notice</b> | 2021-07-001-MKE-005 |

ELI280, MLBUR280 and BUR280 Electrocardiographs

ELI280 resting electrocardiograph - Patient mismatch/Software Upgrade

**FSCA-identifier:** 2021-07-001-MKE-005

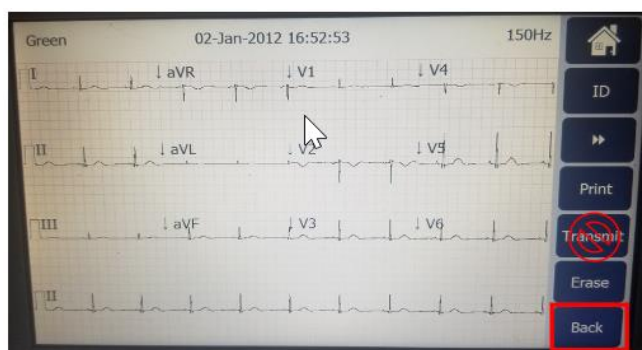
Figure.1

1. An ECG is acquired for Patient A and stored to the cardiograph.
2. An ECG is acquired for Patient B and stored to the cardiograph.
3. The ECG record associated with Patient A is retrieved from memory and any Patient Demographic information is edited.
4. After editing, the "Resting ECG" screen is presented as shown below. Figure 1
5. Pressing the TRANSMIT button from this screen (following any Patient Demographic edit) will transmit an ECG record other than for patient A. (see figure 2, which shows the Resting ECG screen).

If an ECG record is retrieved from the patient directory for a Patient Demographic edit to be performed, once the information has been edited and the screen above (Fig 1) is presented, do not press the transmit button. Instead, press the BACK button which will SAVE the changes to memory and present the user with the following screen, where the SYNC button can be used to transmit the desired record to the configured destination.

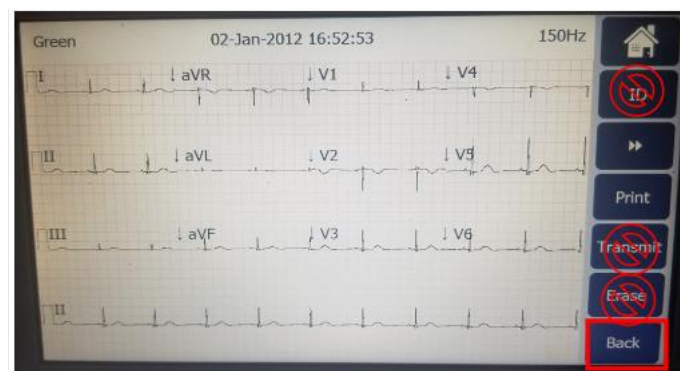
Figure.3

1. An ECG is acquired for Patient A and stored to the cardiograph.
2. An ECG is acquired for Patient B and stored to the cardiograph.
3. The ECG record associated with Patient A is retrieved from memory and ID information is edited.
4. After editing, the “Resting ECG” screen is presented as shown in Figure 3.
5. The user decides to make another ID Edit without leaving the “Resting ECG” screen and presses the “ID” button - Figure 3.

6. After the second edit is performed, the “Resting ECG” screen is once again presented as shown above.
7. Pressing the TRANSMIT button from this screen (following two ID edits in a row as defined above) will transmit an ECG record with the patient demographics

from Patient A and the ECG record for Patient B, this “hybrid” record is then stored in the cardiograph as second record with patient A demographics, and Patient B will no longer be listed in the directory.
