To our customers of the  
Emergency and Transport Ventilator  
Oxylog 3000 *plus*

May 2023

## Important Safety Notice

Oxylog 3000 *plus* may not switch to mains supply following battery operation.

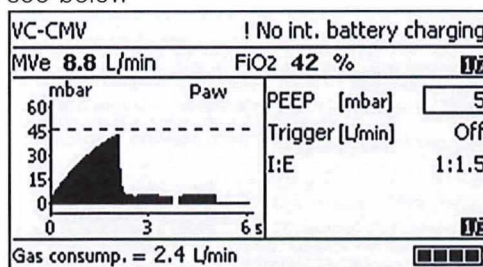
The root cause of the inability to switch to mains supply could be identified as a problem of the charging circuit which can occur in the following sequence of situations:

1. a prior battery issue indicated by the alarm "No int. battery charging" occurred during use on mains supply – see below

Please make sure that the battery is always removed and reinserted or replaced after occurrence of the **"No int. battery charging"** alarm message, without removing the device from mains supply.

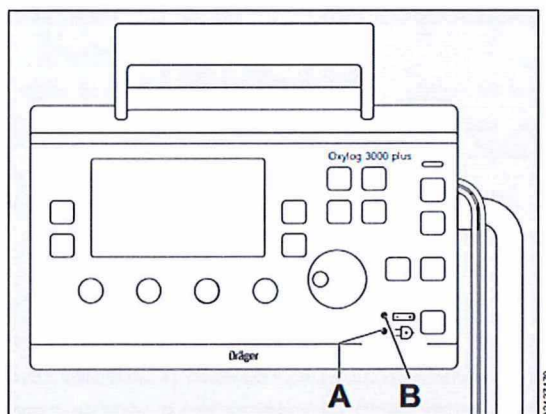
Prior to a device being used on a battery supply, ensure the correct switchover by disconnecting from and reconnecting the device to a mains supply. Please verify the colors of indicators A and B as per the diagram below:

A should display a green light, and B should display a green or yellow light. If B displays a red light, you should disconnect and reconnect or replace the battery.
