**URGENT: FIELD SAFETY NOTICE – MDS-22-4339**

**BD Plastipak™ 50mL Syringe with Luer-Lok™ Tip**

REF: 300865 Lot Number: All within expiry

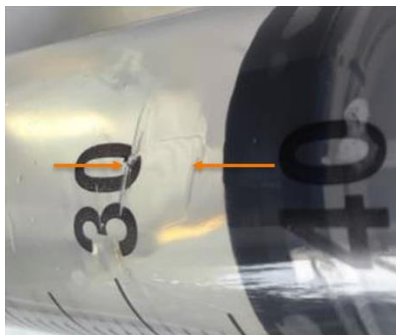
BD has received several customer complaints from hospitals in France involving an observation of air in a damaged syringe while being used in a pump. A damaged syringe barrel (example in Figure 1) could result in a loss of contact between the stopper and the barrel wall, thereby creating a leak path. It is believed that this air ingress, if injected into the patient, could result in a gas embolism.

**Figure 1: Example of syringe barrel damage on BD Plastipak™ 50mL Syringe with Luer-Lok™ Tip**

1. Follow Good Clinical Practice regarding the inspection of medical devices for damage, integrity and function before, during, and after use. Devices found with damage should not be used.
2. If you identify syringe damage, report as a complaint as per your normal process.
3. If you have further distributed the product, please identify those facilities, notify them at once of this Advisory Notice.
4. Complete the customer response form on page 4 indicating that you have read and acknowledge this Advisory Notice.
5. Return the completed customer response form to <<insert contact details here>> as soon as possible or no later than 28/04/2022.

1. BD will be updating the product labelling to state: "Do not use if product or packaging is damaged."
2. Following an investigation performed by engineering and quality personnel at the manufacturing site, engineering process enhancements have been identified to improve the detection and rejection of damaged syringes. These enhancements will be implemented in March 2022.
