**URGENT**  
**Field Safety Notice**  
**125ml and 225ml Cell Saver Centrifuge Bowls**

RCL-100284-IE(AA)

125ml and 225ml Cell Saver Centrifuge Bowls

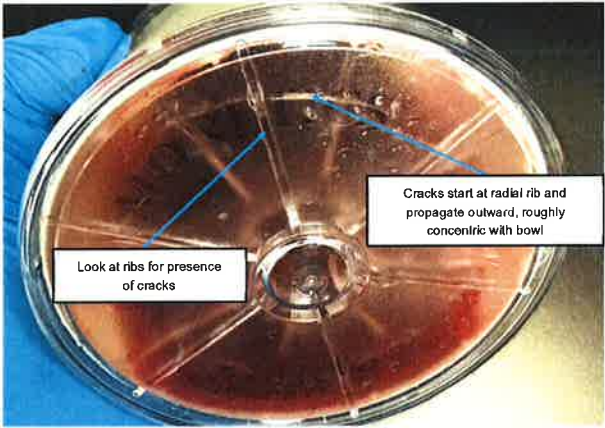
| NEW TROUBLESHOOTING TO BE ADDED | <ul style="list-style-type: none"> <li>Check the base of the bowl for cracks extending from the ribs.</li> </ul> <p><b>Explanation:</b><br/>The disposable set has been damaged by the centrifugal forces applied and developed cracks on the inner core. There should be no blood external to the bowl. This however may lead to fluid becoming trapped inside the bowl which may contain hemolysed blood or blood that has not been sufficiently washed. The alert prompts the user to take the following corrective actions.</p> | <ol style="list-style-type: none"> <li>If an error code continues to indicate “Long Empty,” after the above steps the user should remove the bowl, tilt upside down and visually check the base for cracks directly on or extending from the ribs. See photo below for where to inspect: <ol style="list-style-type: none"> <li><b><u>If no cracks are observed</u></b><br/>Proceed with using the blood in the reinfusion bag. No further action is required. If the problem persists contact your technical service centre.</li> <li><b><u>If cracks are observed</u></b><br/>The user should assume incomplete washing of the bowl contents. The wash cycle should be repeated on the blood that is in the reinfusion bag. Remove the processing set and install a new processing set. Contact your customer service representative to return the set.</li> </ol> </li> </ol> <p>Take any residual RBCs in the reinfusion bag and empty the contents into the cardiotomy reservoir to repeat the wash cycle using a <u>new</u> processing set. The salvaged blood may be reinfused to the patient.</p> |

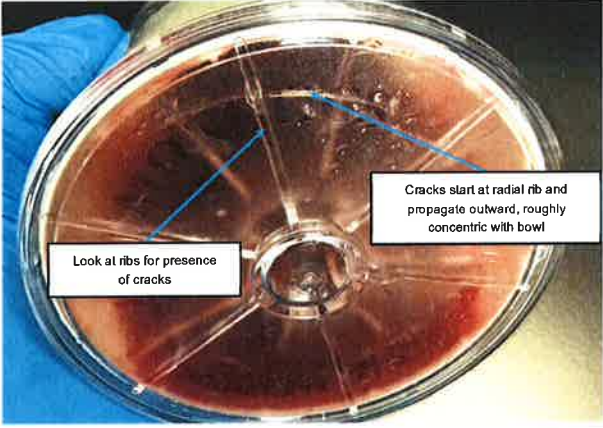
| NEW TROUBLESHOOTING TO BE ADDED | <ul style="list-style-type: none"> <li>• Check the base of the bowl for cracks extending from the ribs.</li> </ul> <p><b>Explanation:</b><br/>The disposable set has been damaged by the centrifugal forces applied and developed cracks on the inner core. There should be no blood external to the bowl. This however may lead to fluid becoming trapped inside the bowl which may contain hemolysed blood or blood that has not been sufficiently washed. The alert prompts the user to take the following corrective actions.</p> | <ol style="list-style-type: none"> <li>4. If an error code continues to indicate “Long Empty,” after the above steps the user should remove the bowl, tilt upside down and visually check the base for cracks directly on or extending from the ribs. See photo below for where to inspect: <ol style="list-style-type: none"> <li>a. <b>If no cracks are observed</b><br/>Proceed with using the blood in the reinfusion bag. No further action is required. If the problem persists contact your technical service centre.</li> <li>b. <b>If cracks are observed</b><br/>The user should assume incomplete washing of the bowl contents. The wash cycle should be repeated on the blood that is in the reinfusion bag. Remove the processing set and install a new processing set. Contact your customer service representative to return the set.</li> </ol> </li> </ol> <p>Take any residual RBCs in the reinfusion bag and empty the contents into the cardiectomy reservoir to repeat the wash cycle using a <u>new</u> processing set. The salvaged blood may be reinfused to the patient.</p> |
