January 16, 2025

## **URGENT MEDICAL DEVICE CORRECTION**

### **Model 1000 SenTiva™ and Model 1000-D SenTiva Duo™ VNS Therapy™ Generators**

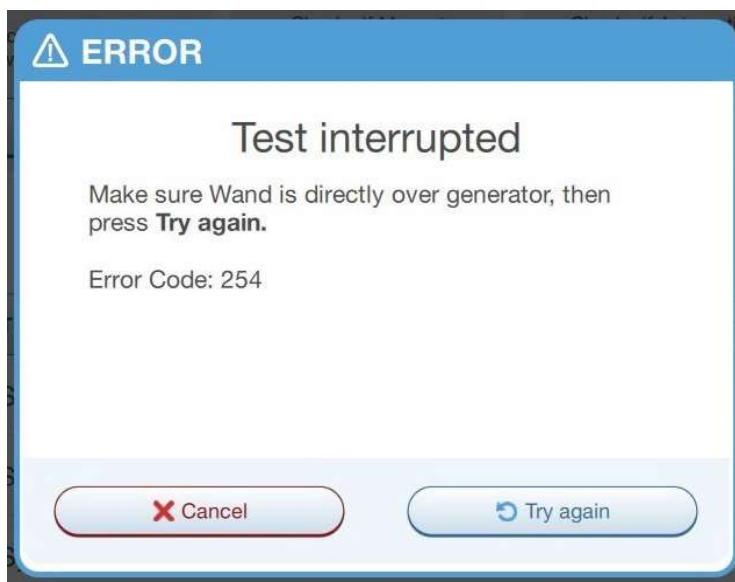
- For all generators, perform an on-demand System Diagnostic test (using the Diagnostics tab in the programming software) at every clinic visit to confirm proper function of the generator. A generator with a reed switch stuck in the closed position will display “Error Code 254 – Test Interrupted” on a Model 3000 programmer when a diagnostic test is attempted using the VNS Therapy Programming System (see Figure 1).

*Figure 1: “Error Code 254 – Test Interrupted” message encountered during System Diagnostic Testing*

**Note:** The diagnostic test that is performed as a part of the initial interrogation to enter a session will NOT detect this event.

2. Contact LivaNova Customer Quality by phone at +1-281-228-7330 or by e-mail at [cservices@livanova.com](mailto:cservices@livanova.com) if communication with the generator using the VNS Therapy Programming System indicates that:

- i. Diagnostic tests cannot be performed ("Error Code 254 – Test Interrupted" error message)
  - ii. Programming changes cannot be made ("Error Code 254 – Apply Changes Interrupted" error message); or

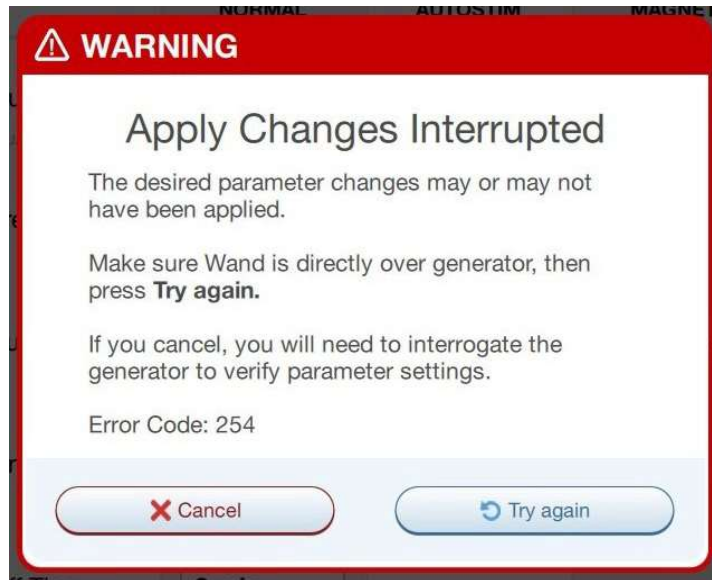
- A generator with a reed switch stuck in the closed position may also prevent parameter changes from being made with the programming system. The programmer may display “Error Code 254 – Apply Changes Interrupted” (see Figure 2).

Figure 2: “Error Code 254 – Apply Changes Interrupted” message encountered during programming

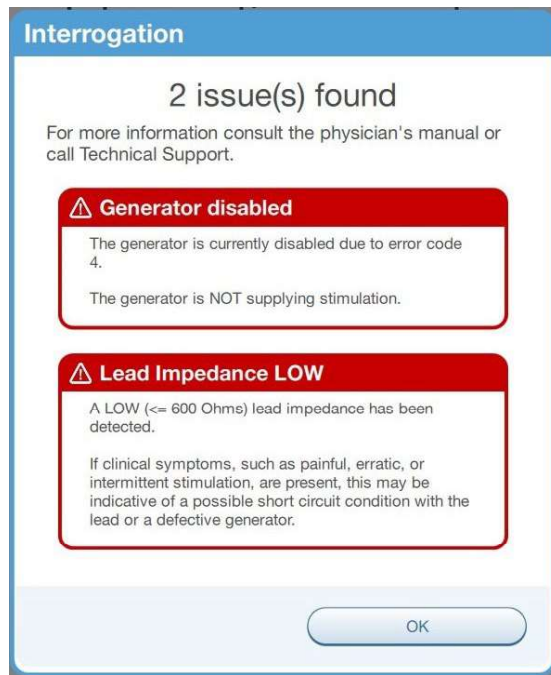
- An on-demand System Diagnostic test may result in LOW lead impedance for some generators with a reed switch stuck in the closed position (see Figure 3).

Figure 3: Low lead impedance error message

- iii. System Diagnostic test displays a "LOW" lead impedance result.
3. Encourage patients to do the following:
  - i. Notify you if they perceive a change in clinical symptoms (e.g., increase in seizures or depressive symptoms).
