URGENT Field Safety Notice

Wired Avalon Ultrasound Transducer (product number 867246)
Inaccurate Fetal Heart Rate (FHR) measurements when monitoring multiples

22-MAY-2024

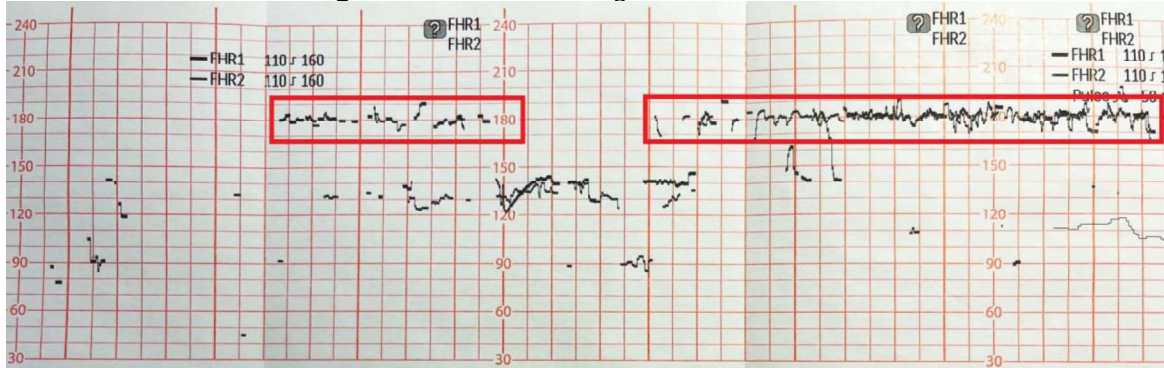
It was found that the latest version of the wired Avalon Ultrasound Transducers (867246) may report inaccurate Fetal Heart Rate (FHR) measurements when monitoring multiples (twins or triplets): In situations where the physiological signal (echo from the fetal heart) is absent or very weak (e.g. in early weeks of pregnancy), there is a tendency of the wired Ultrasound transducers to interfere with each other and subsequently to produce an artificial FHR, mostly at approximately 180 bpm. The use cases affected by this issue are twin or triplet monitoring with wired Ultrasound Transducers including at least one transducer with software version L.01.04. The population at risk is women with multiple gestation (twins/triplets).

Figure 1 below shows an example trace of FHR measurements when this issue occurs. Highlighted in red are the sections of the trace which show the issue as it would be present for the clinical user.

Figure 1. FHR Trace During Occurrence of Issue

1. The affected Avalon wired transducer with software revision L.01.04 must not be used when monitoring multiples.
2. The Avalon wired Transducer 867246 can be safely used in the following cases:
 - a. Monitoring the FHR of singletons (ca. 97% of all pregnancies) with any wired Avalon Ultrasound Transducers, including 867246 Ultrasound Transducer with software revision L.01.04.
 - b. Monitoring also of twins or triplets with wired Ultrasound Transducers, as long as none of the involved transducers is an 867246 Ultrasound Transducer with software revision L.01.04.

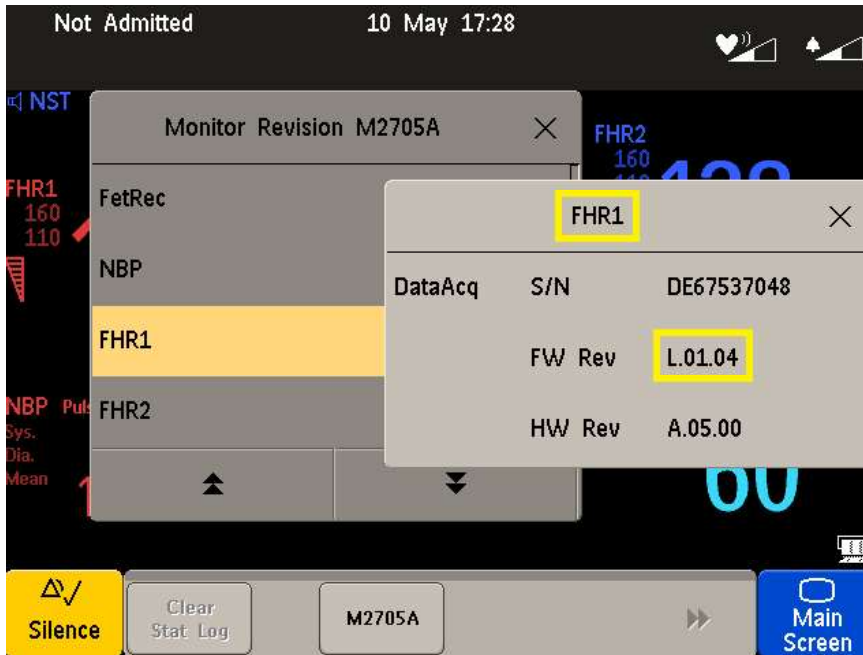
1. Enter the Software Revisions screen in the fetal monitor graphical user interface:
Main Setup > Revisions > [FHR to check, e.g. FHR1]

Figure 2. Checking the Transducer Software Revisions at the Avalon FM display

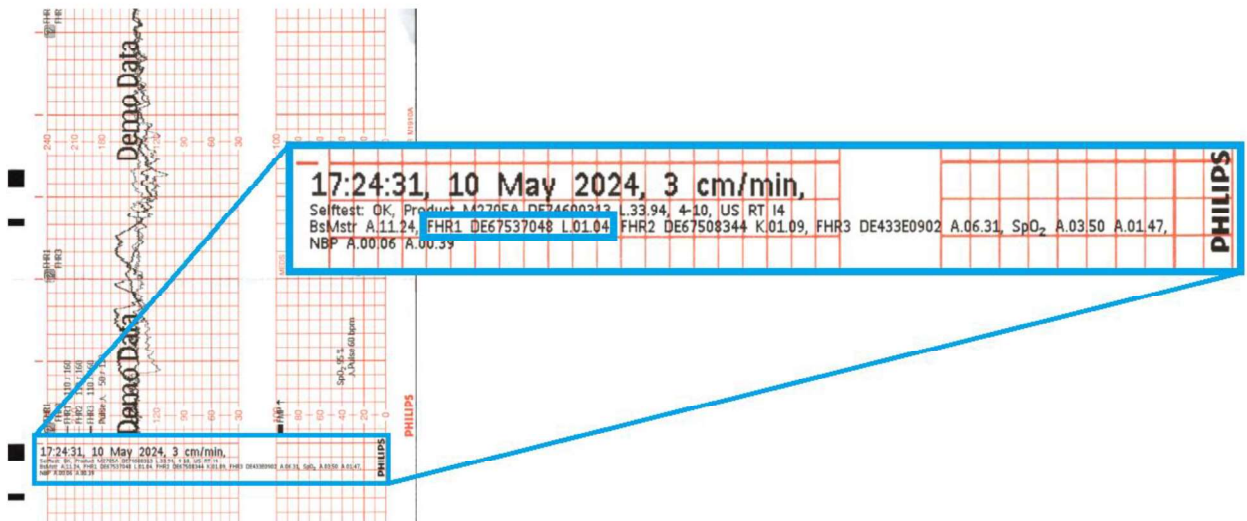
2. Review the recorder header of a printed trace

Figure 3. Checking the SW revisions of all connected transducers with the recorder header information
