**Subject: URGENT - FIELD SAFETY NOTICE – Integra – Codman® CereLink® ICP Monitor, Model: 826820: ICP Monitor Reading Default – Field Safety Notice**

826820 - Codman® CereLink® ICP Monitor  
All serial numbers ranging from CLK2111003 to CLK2215542

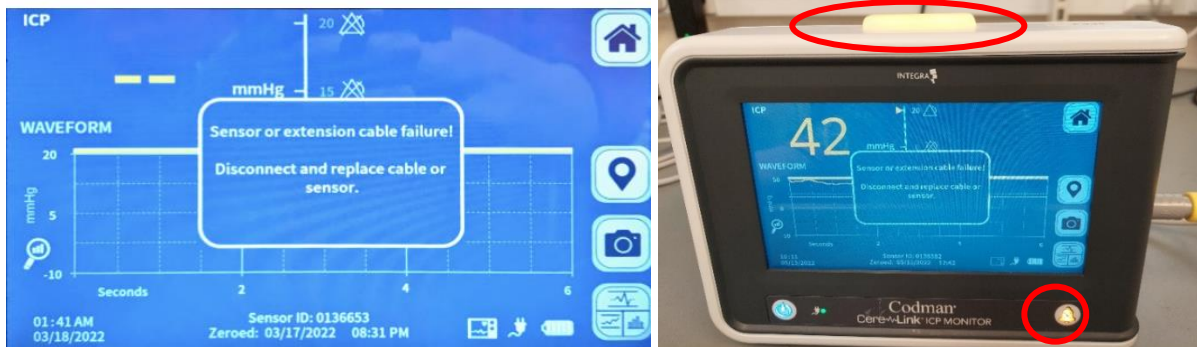
**Figures 1 (left) and 2 (right): Visual alarms including display and flashing light alarm**

- Per standard clinical practice, patients are consistently monitored at the patient bedside, making it more likely that an abnormal ICP would be detected using clinical exam and other vital signs.
- Audible and visual alarms on the CereLink® ICP Monitor are triggered in the event of an out-of-range reading to inform the user that the failure mode is occurring (see Figures 1 and 2).

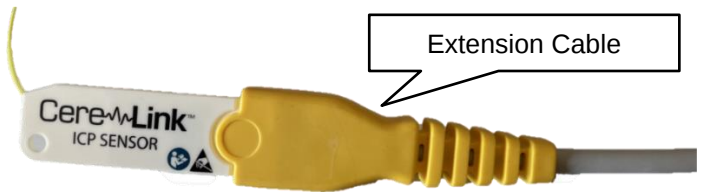
| 1. | <p>Make sure the <b>CereLink® ICP Sensor is connected correctly (fully seat) into the CereLink® ICP Extension Cable</b> (included with the monitor; also available separately under product code 826845).</p> |
