Urgent Field Safety Notice (FSN)

Replacing the power supply unit
for care beds in the Ecofit range

23.04.2024

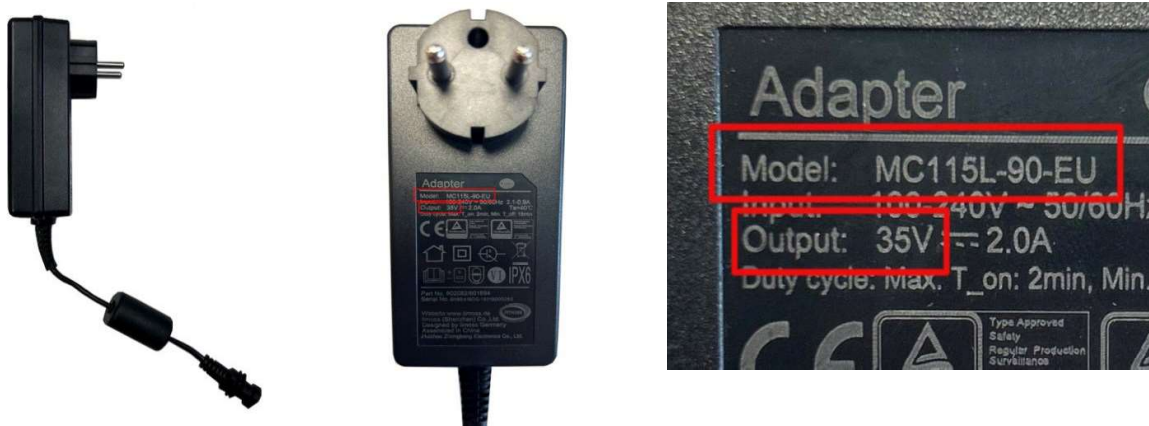
This only applies to Ecofit care beds with the built-in power supply unit **MC 115L-90-EU** (manufacturer limoss GmbH) and an output voltage of **35V**. The attached list shows the serial numbers of all products (see cover sheet) for which the power supply unit needs to be replaced.

Please replace the MC115L-90-EU power supply unit with the PS1102 power supply unit provided free of charge by tecfor care for care beds from the Ecofit range in your inventory or during the next maintenance. Instructions for replacement can be found in the appendix to this letter.

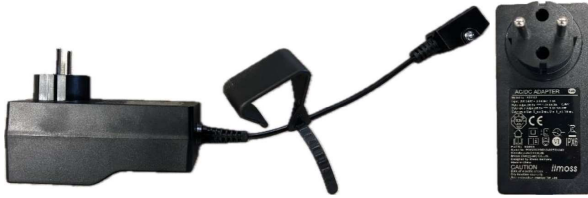
ANNEX:**Instructions: Replacing the power supply unit**Scope of delivery:

Description:**Plug-in power supply SMPS - PS1102**

200-240V, 50-60Hz, 2,4A, IPX6

Model number: 503605

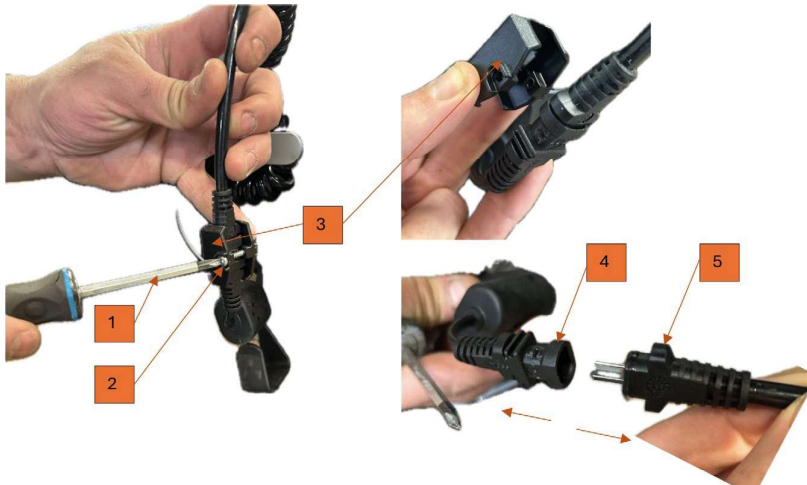
1. To remove the previously installed power supply unit, use a screwdriver (1) to loosen the screw (2) on the safety cap of the plug connection.
2. You can then remove the protective cap (3) with little effort.
3. Now release the plug connection (4+5) by pulling in the opposite direction.

1. Take the new plug from the scope of delivery and fit it in the opposite direction as described in the "Disassembly" section.
2. Once steps 3-1 have been carried out, the power supply unit is ready for use and can be reconnected to the mains supply.
